# OEM's Approach to Widespread Fatigue Damage

Steve Perry, Principal Engineering Specialist, CSALP  
15 November 2018

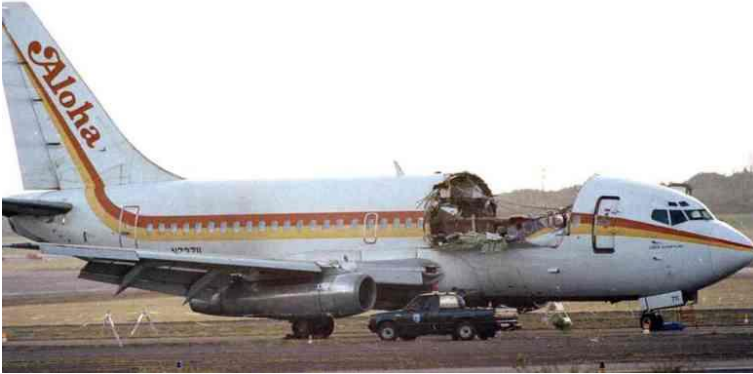
- 28 April 28, 1988, Aloha Airlines flight Hilo to Honolulu
- Lost area of cabin at 24000 feet
- Landed at Kahului
- One crew member died, one crew member and seven passengers seriously injured
- NTSB/AAR-89-03:
  - probable cause was the failure of the maintenance program to detect significant disbonding and fatigue damage
  - Contributing factors:
    - failure of Aloha Airlines management to supervise properly its maintenance force
    - failure of the FAA to require inspection of all the lap joints proposed by Boeing
    - lack of a complete terminating action after discovery of early production difficulties in the lap joint which resulted in low bond durability, corrosion, and premature fatigue cracking

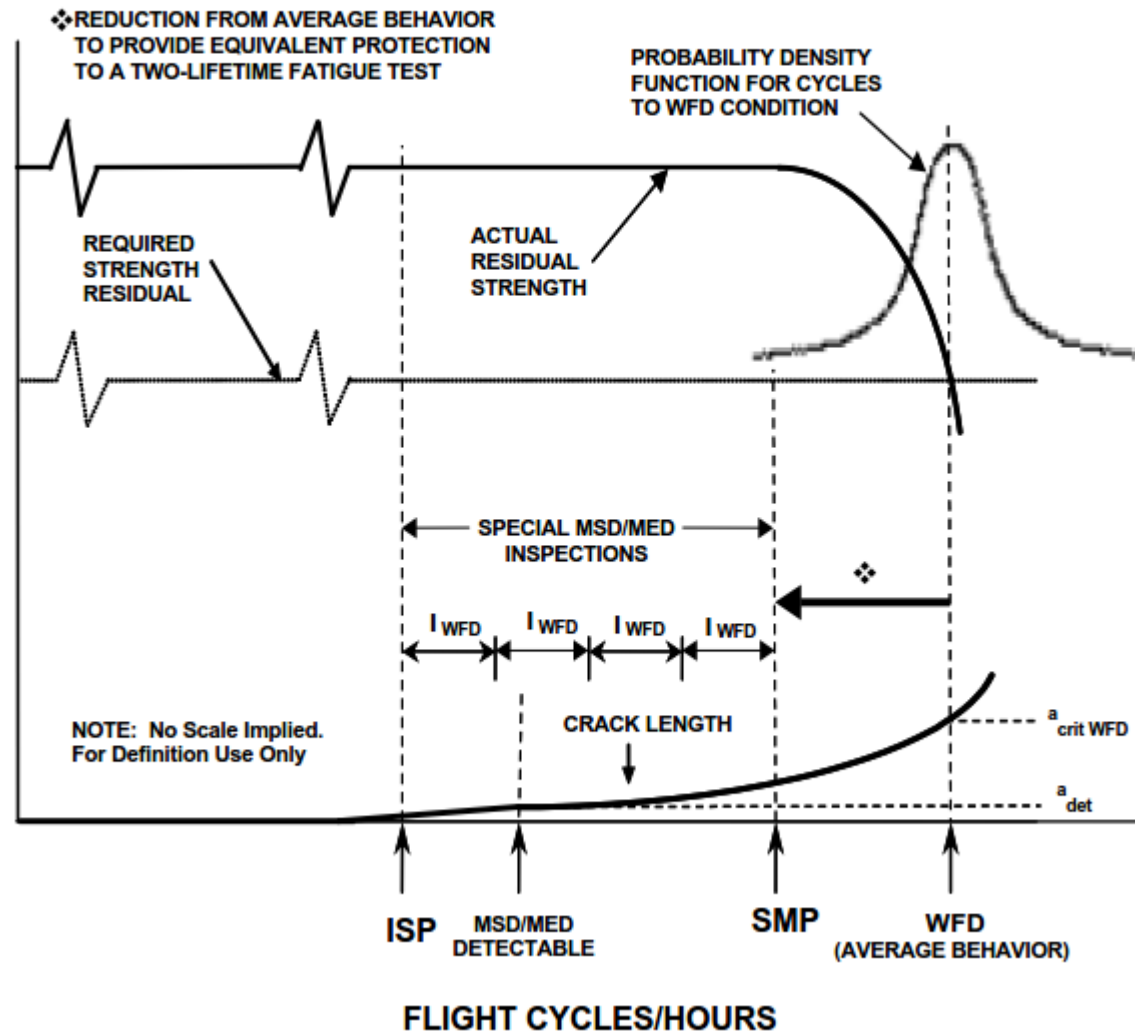
Figure 6-3  
MSD/MED Residual Strength Curve  
(Including WFD Inspections)

# Implementation - WFD (average behavior), ISP, SMP

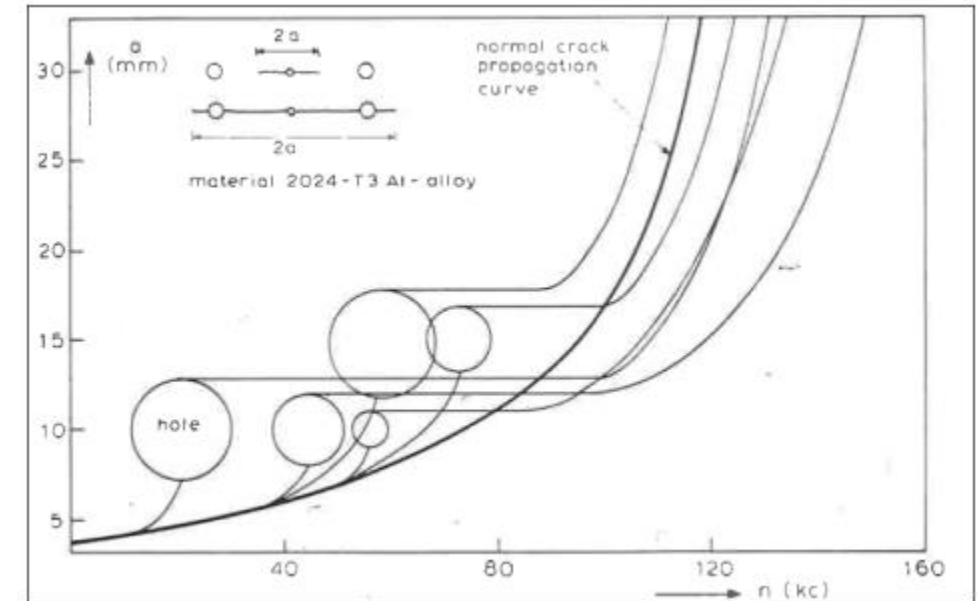
## MULTI-SITE DAMAGE CRACK GROWTH AND RESIDUAL STRESS ANALYSIS

- Where there are findings in a lap joint, say, a more complex approach may be required
- A tool has been developed to model a lead crack growing in a row of holes in the presence of damage at each hole

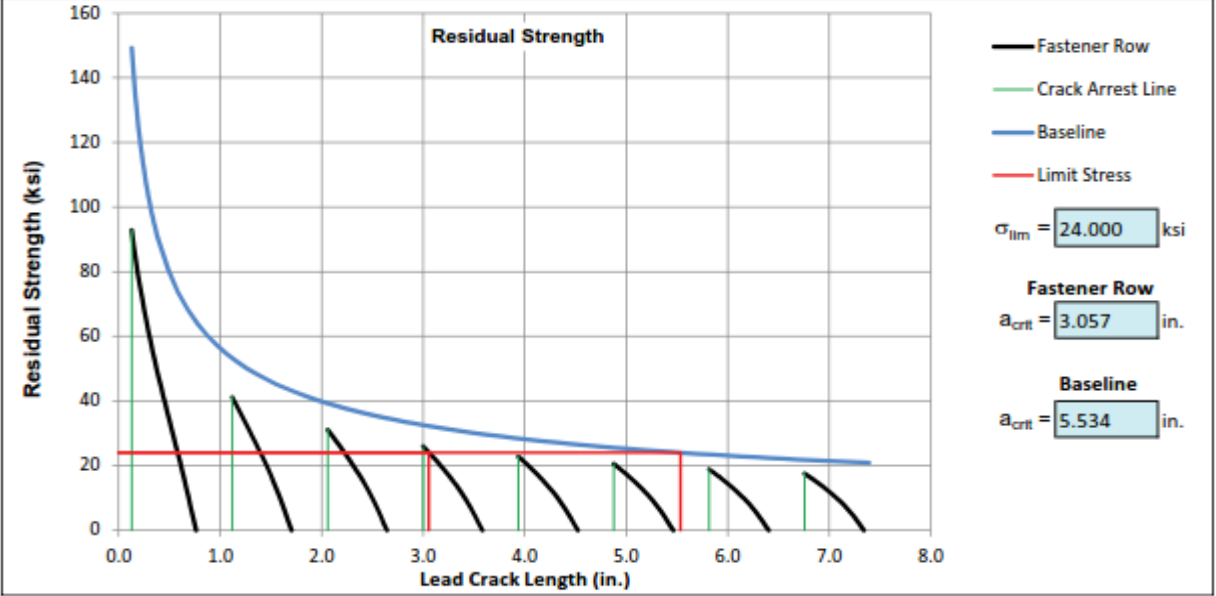
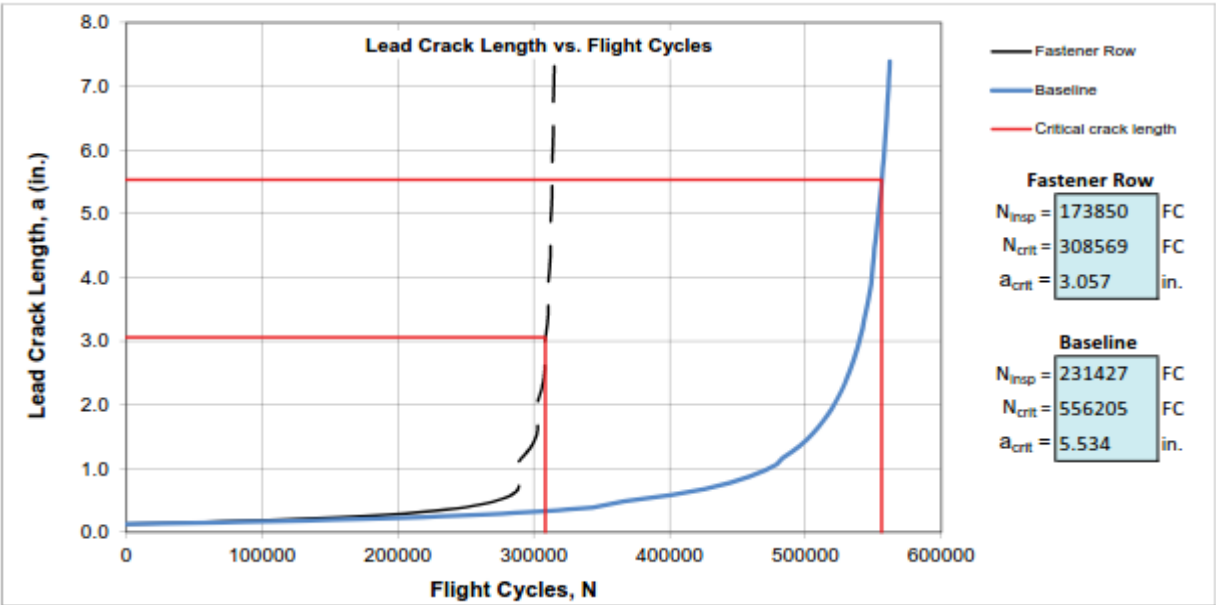
Baseline scenario is a two-tip crack growing from an open hole in an infinite panel provided by NASGRO TC23

This is compared with the same crack growing in the presence of MSD

Factors derived to apply to threshold and repeat interval to account for test findings

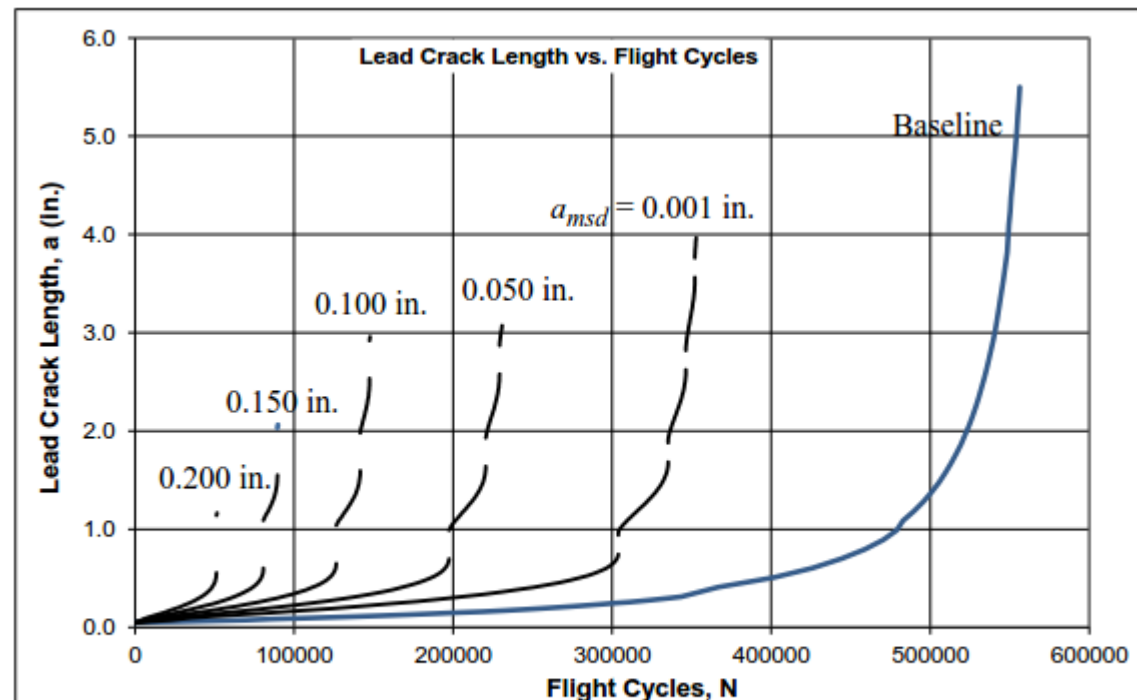
FIGURE 7 Effect of  $a_{msd}$  on Crack Growth and  $a_{crit}$

- MSD
  - effectively eliminates the re-nucleation retardation that allows the baseline model to ignore the presence of holes ahead of the lead crack
  - Accelerates lead crack growth by link-up and interaction with crack tip stress fields
  - Reduces critical crack length

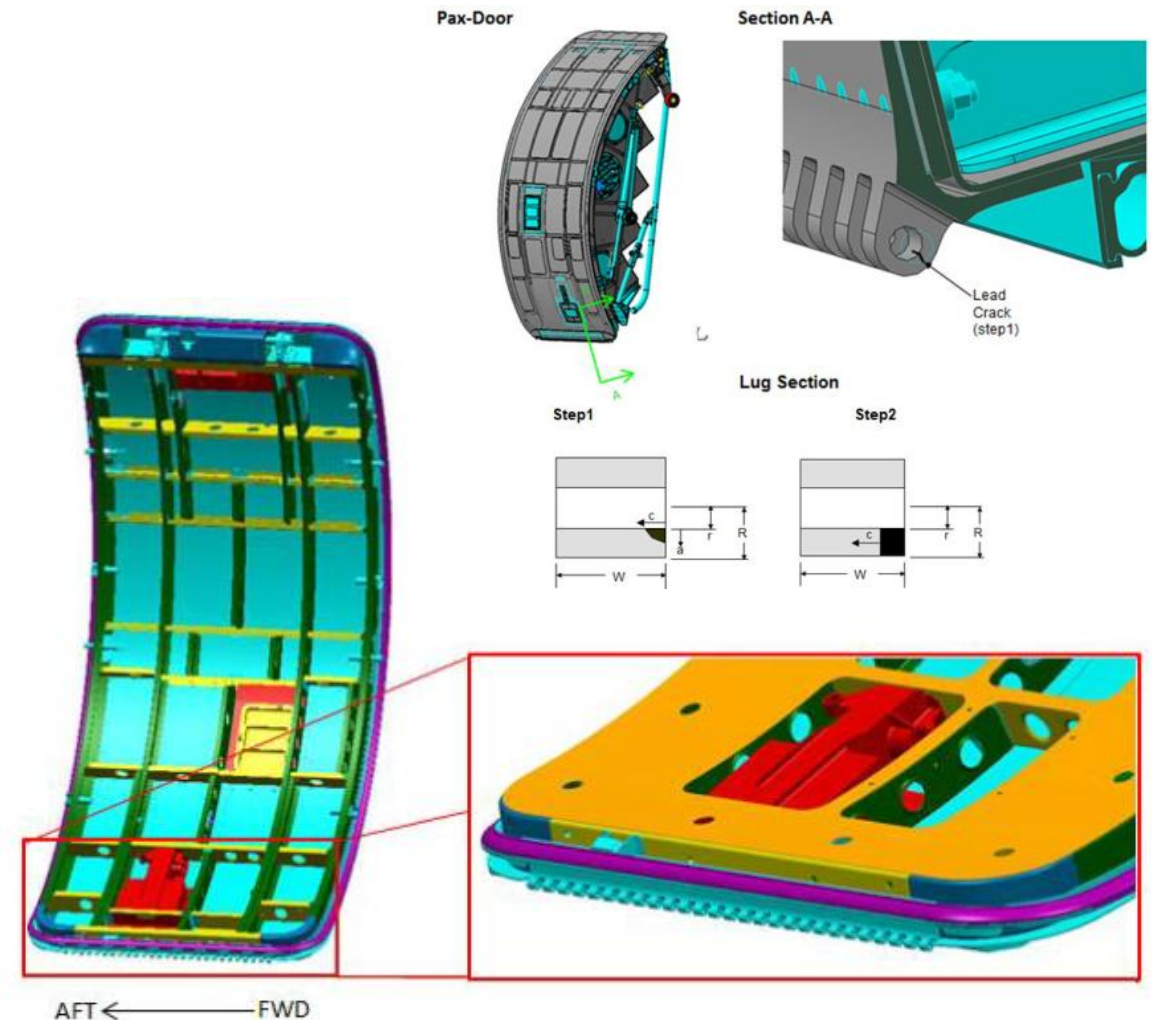
- PSE 52-11-P03, Passenger Door Piano Hinge

No cracks found at end of 160,000FC

Detectable crack in hole = 0.040"

Assume  $c_{\text{initial}} = 0.040"$

$N_{\text{crit}} = 46,200$  FC by DTA

$WFD_{\text{average behavior}} = 160,000 + (46,200 - 0) = 206,200$  FC

ISP =  $206,200 / 3 = 68,700$  FC

SMP =  $206,200 / 2 = 103,100$  FC > LOV

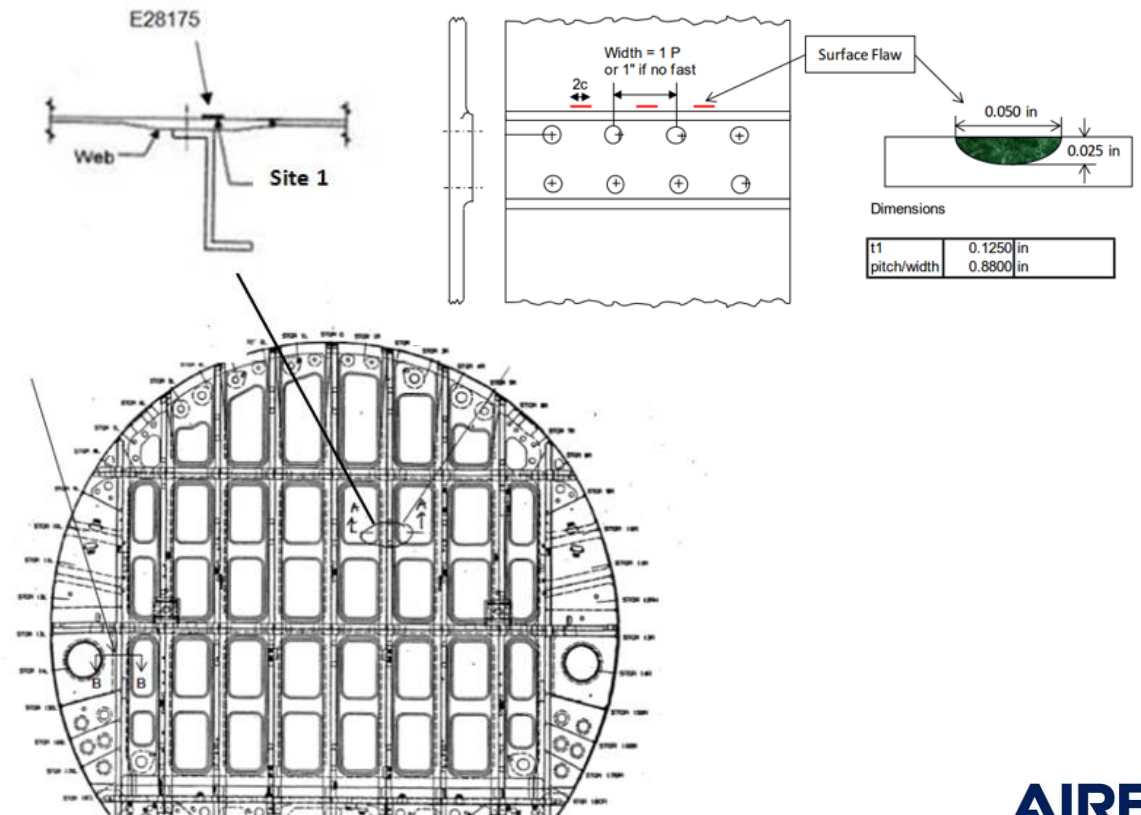
- PSE 53-41-P14, Aft pressure Bulkhead – Beam to Web Structure

Bulkhead was replaced on test at 60,000 FC, so only 100,000 FC accumulated – no cracks found

Assume  $c_{\text{initial}} = 0.025"$

$N_{\text{crit}} = 190,182$  FC by DTA

$WFD_{\text{average behavior}} = 100,000 + (190,182 - 0) = 290,182$  FC

ISP =  $290,182 / 3 = 96,700$  FC > LOV

SMP =  $290,182 / 2 = 145,000$  FC > LOV

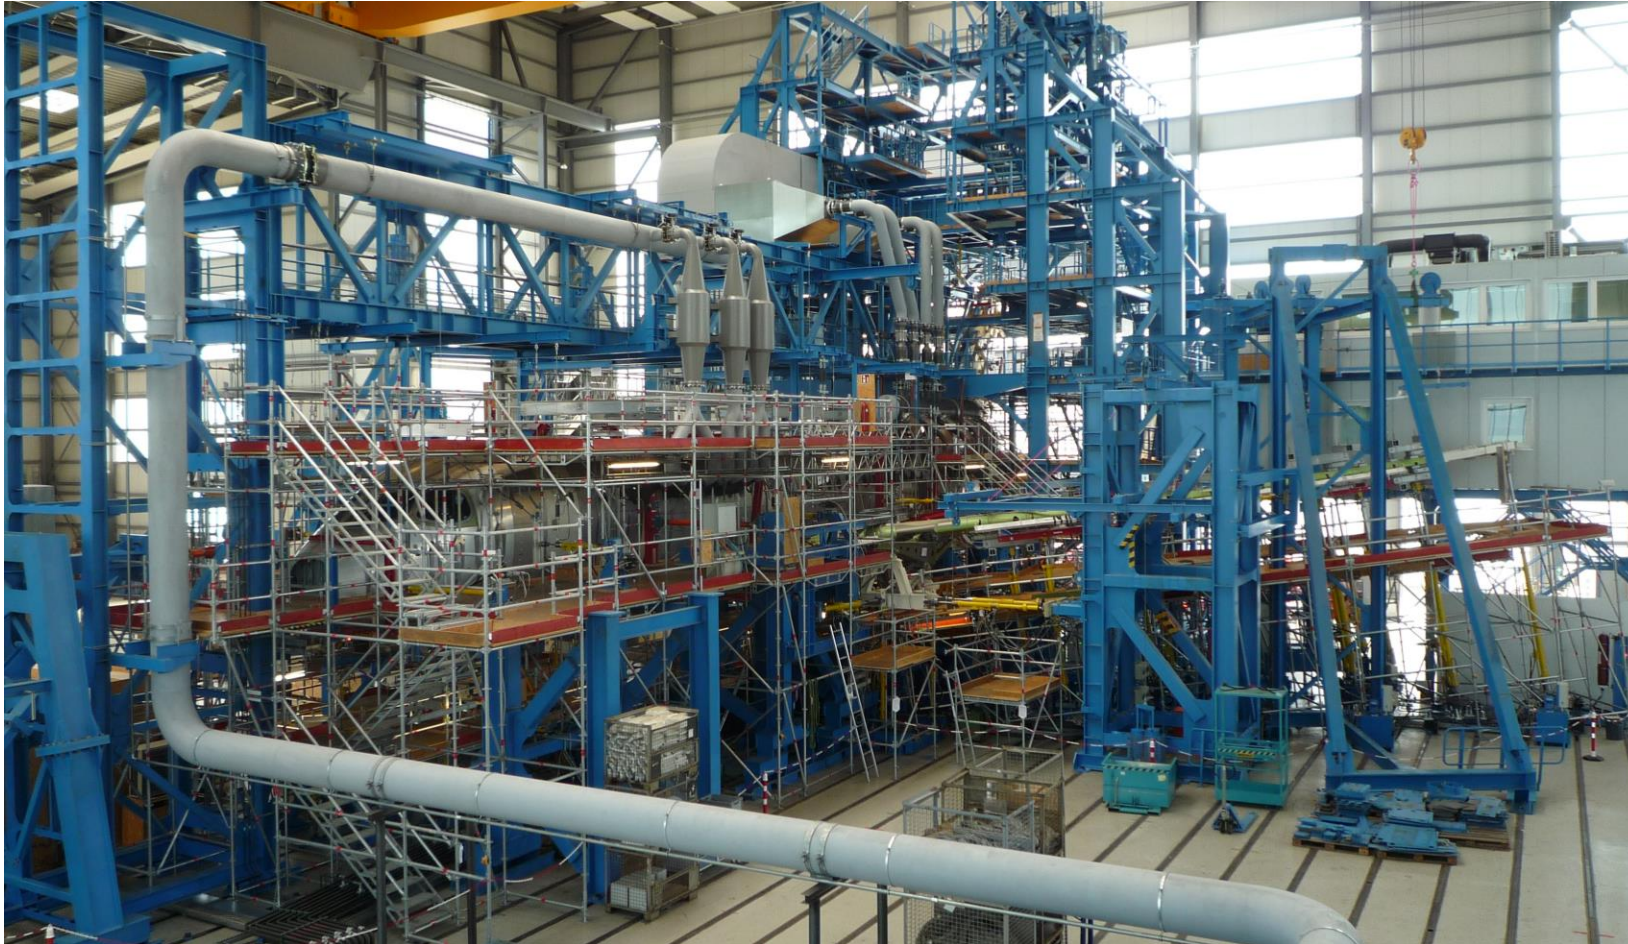
- DADT at IABG in Dresden, Germany
